# Technical Service Bulletin

## 19 loss of coolant from coolant pump - V6 TFSI

19 23 45 2070349/2 November 1, 2023. Supersedes Technical Service Bulletin Group 19 number 23-39 dated May 17, 2023 for reasons listed below.

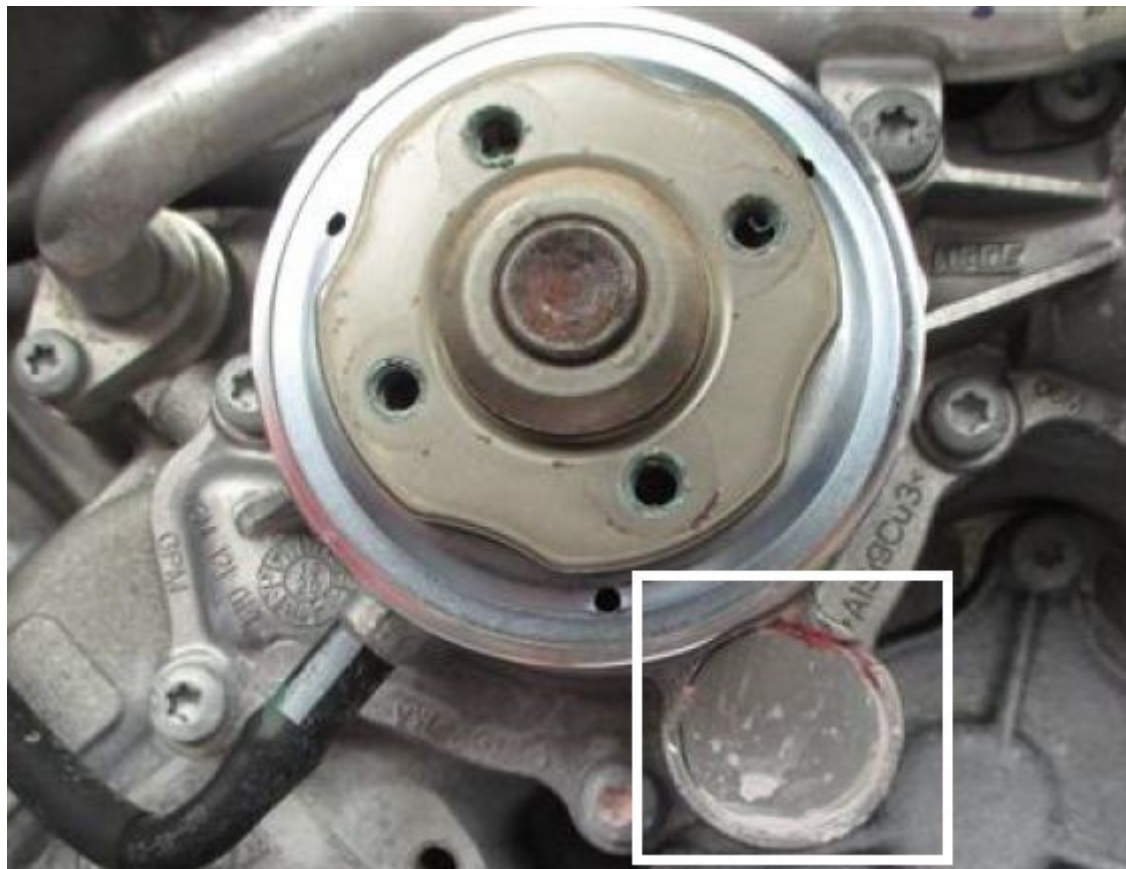
Traces of coolant (small quantity) on drip cup (refer to figure 1).

Due to lubrication/cooling of the seal, up to 3 ml may escape over the course of 100 hours of operation. This is quite normal and does not constitute a reason for a complaint.

**Figure 1:** Traces of coolant on the drip cup.
